ACCEPTABLE GLASS WINDOW/WINDSHIELD REPAIR PROCESSES AND APPROVED VENDORS

RICHARD J. OLSON

BATTELLE
505 KING AVENUE
COLUMBUS, OH 43201

MATERIAL AND PROCESS SPECIFICATION REPORT FOR 09/91 - 12/31/95
CONTRACT NUMBER FO9603-90-D-2217-SD02

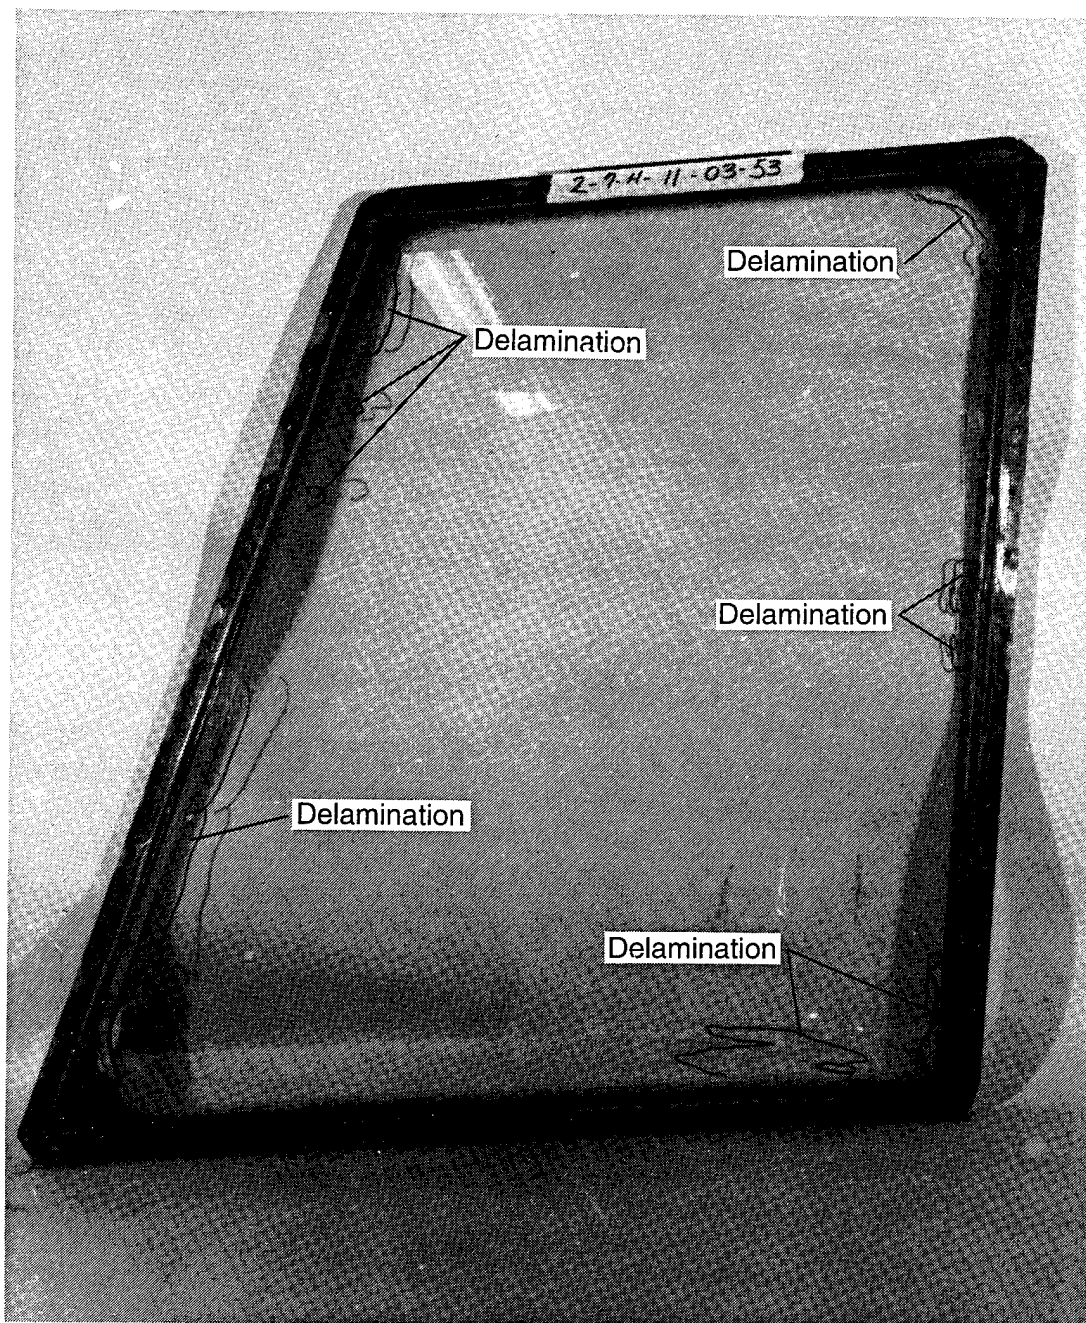
**Figure 4.1 Worst Delamination Observed in All Pressure/Thermal Cycle Tests
(B-52 #1 W/WS, S/N 7-H-11-03-53)**

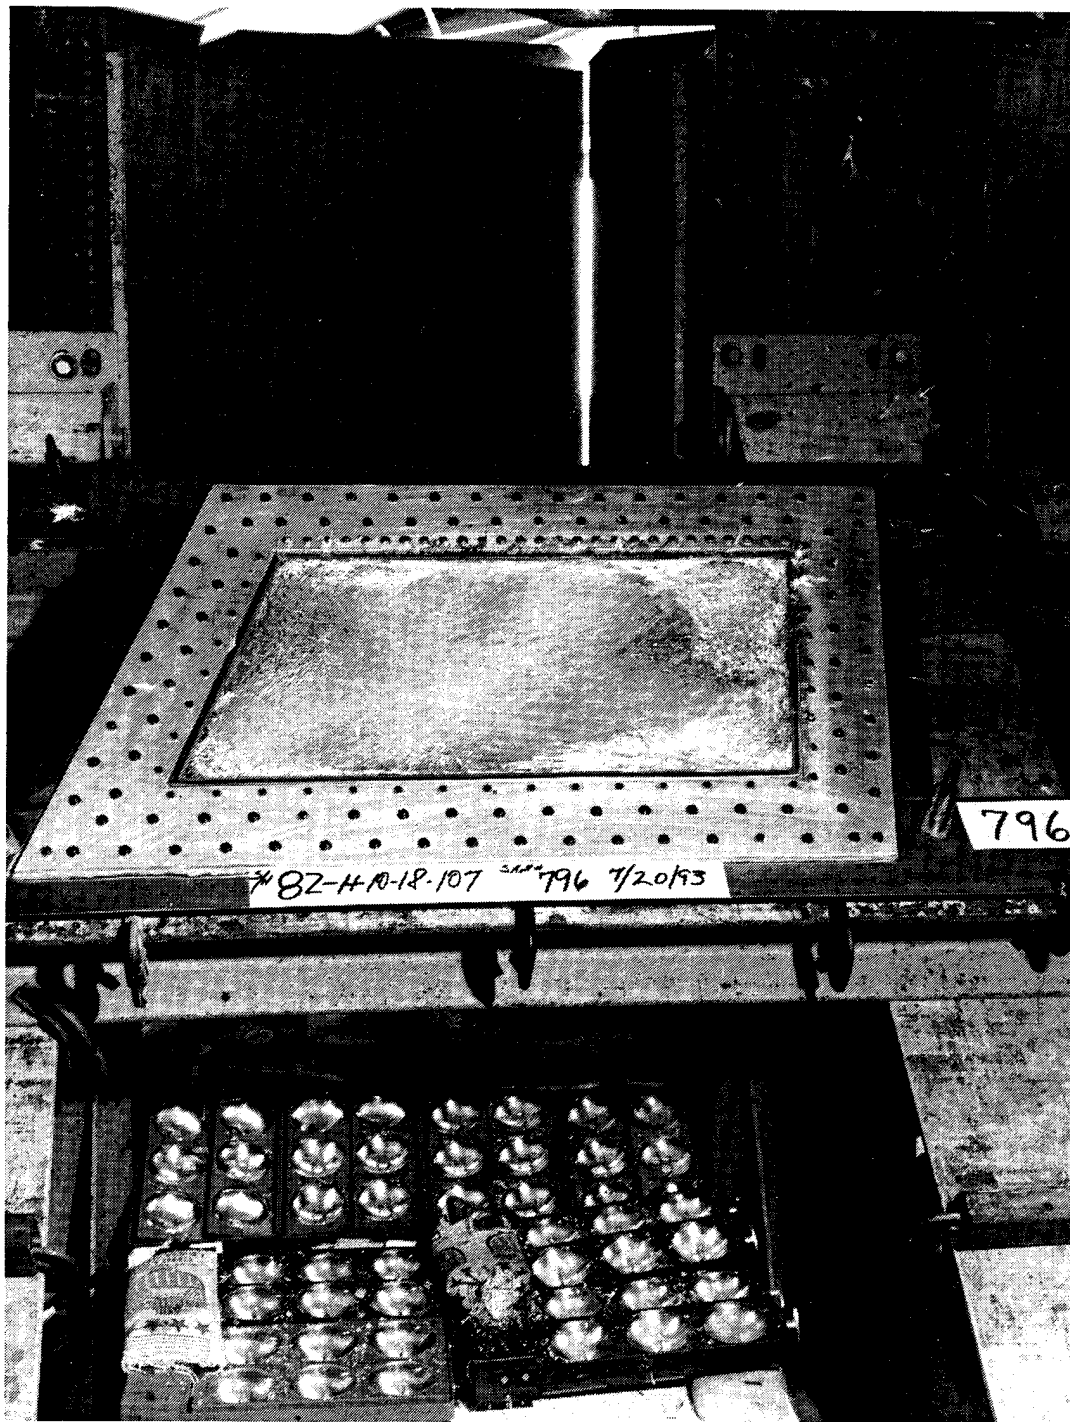
**Figure 4.3 Both Glass Plies Failure From a 4-Pound Bird Impact at 250 Knots
(C/KC-135 W/WS, S/N 83-H-11-21-325)**

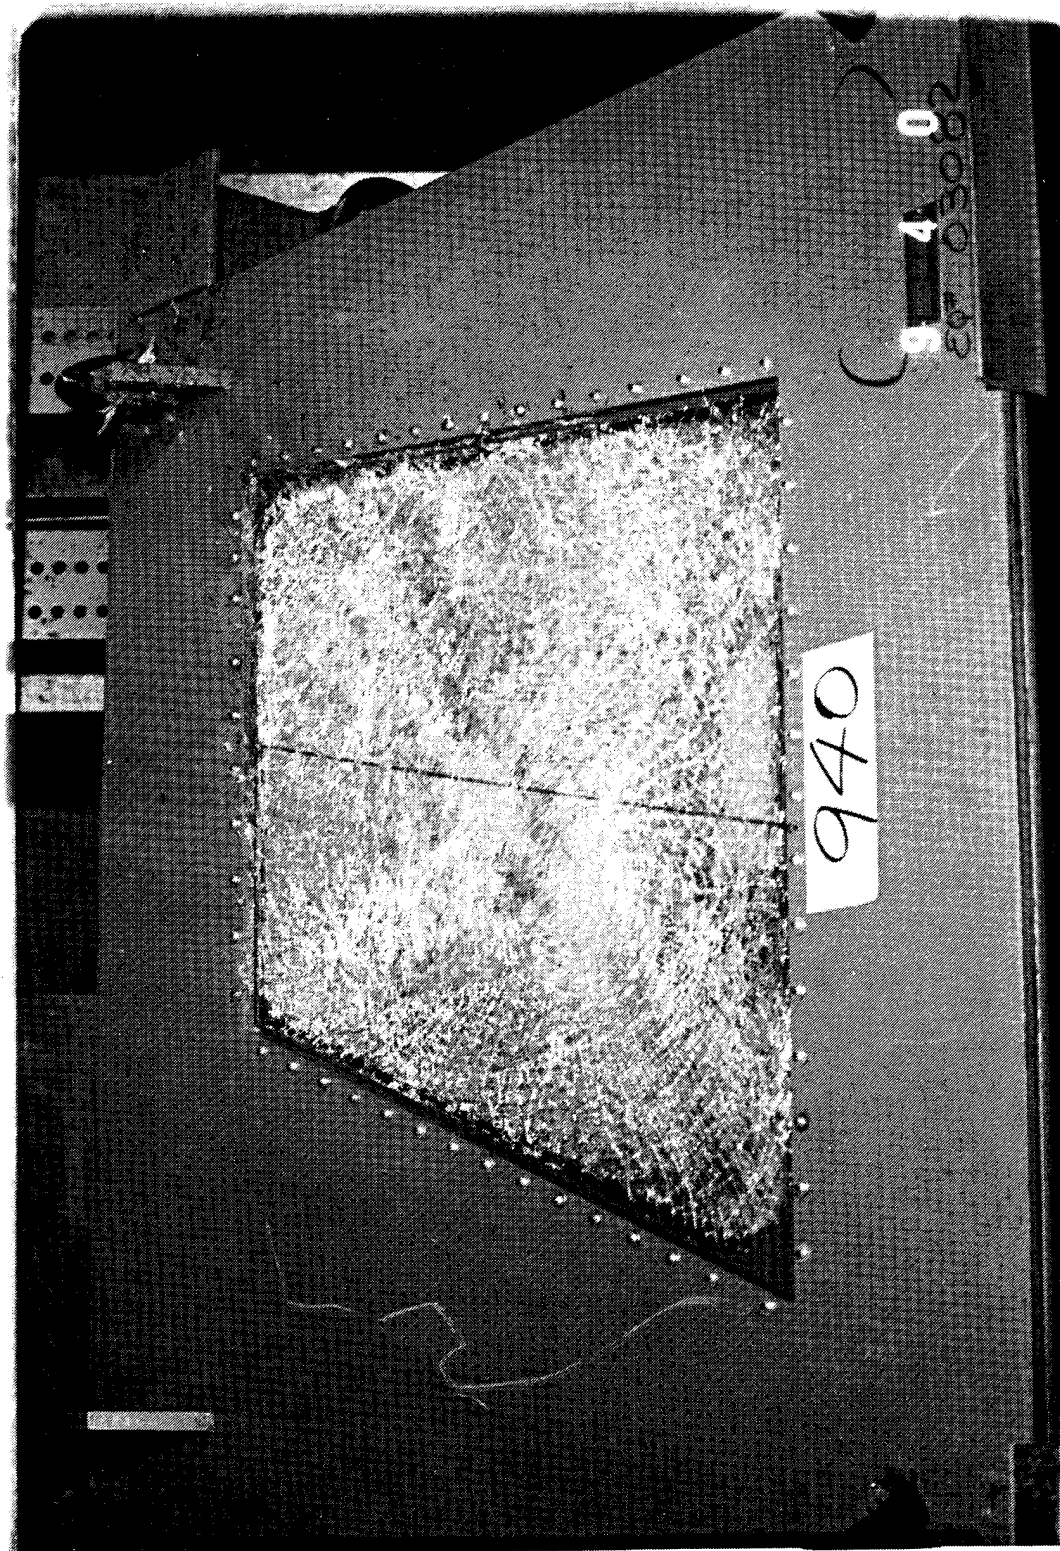
Figure 4.4 Broken Outboard Glass Ply Failure From a 4-Pound Bird Impact at 300 Knots
(B-52 #2 W/WS, S/N 5-H-3-21-17)
